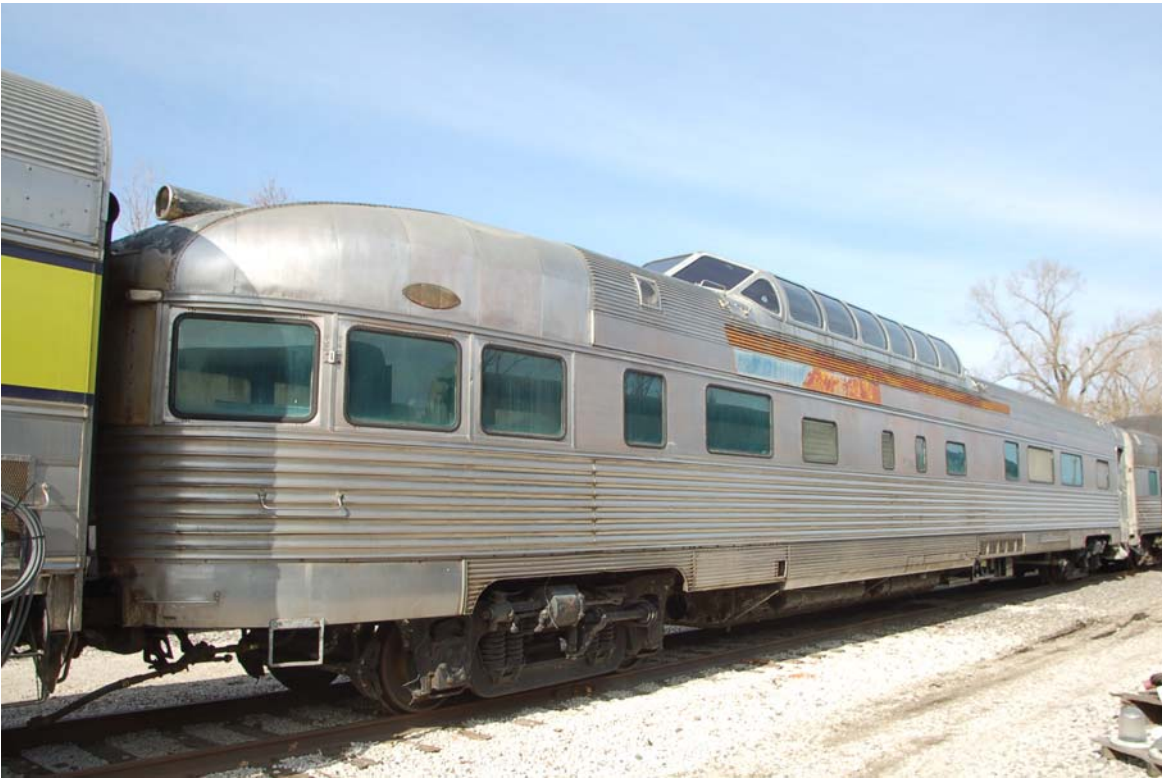
2 New AC Units

2 new NWRAIL condensing units have been hung under the car
1 new NWRAIL overhead heat, evaporator, blower system has been installed at the "A" end of the car.
1 new NWRAIL overhead heat, evaporator, blower system has been purchased for the "B" end of the car but has not been installed.
Floor heat strips have been installed.

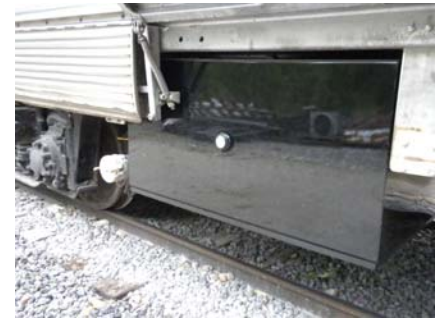
New holding Tank

A new holding tank and all the plumbing has been installed under the car.
Water tank shrouds have been removed and cleaned. Under carriage has been cleaned very well.

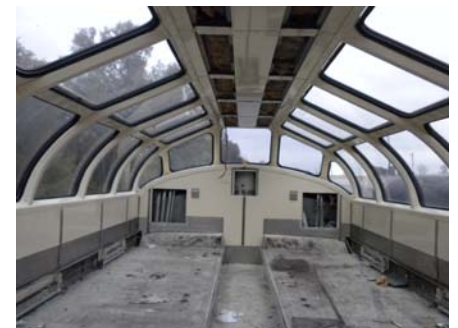
New Dome Glazing & Interior Paint

All new glazing/gaskets has been installed in the dome.

A brand new restroom has been built at the "B" end of the car. Interior of the dome area has been prep and painted. Lower level walls and ceiling has been prepped for painting.
